# **NATIONAL TRANSPORTATION SAFETY BOARD**

## **RAILROAD ACCIDENT REPORT**

**DERAILMENT OF AMTRAK TRAIN 4, SOUTHWEST CHIEF,  
ON THE BURLINGTON NORTHERN SANTA FE RAILWAY  
NEAR KINGMAN, ARIZONA  
AUGUST 9, 1997**

**Notation 6912B  
Adopted August 31, 1998**

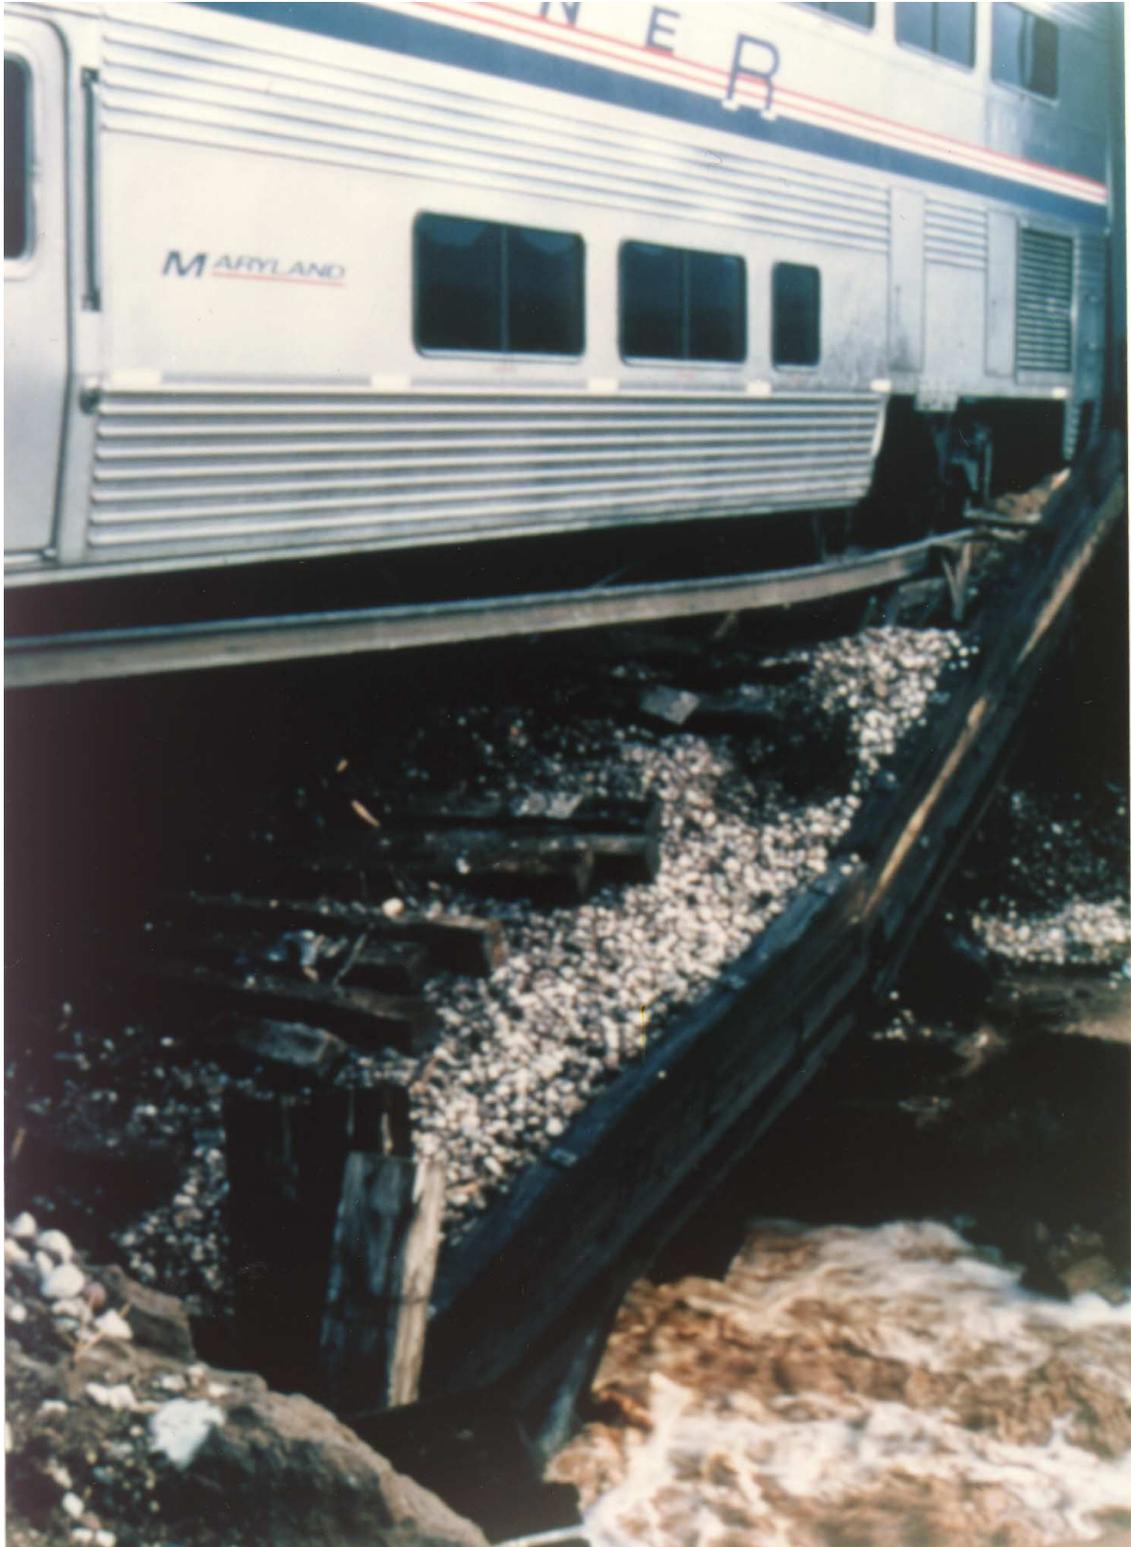
Figure 4. Flow of water under bridge 504.1S after the derailment

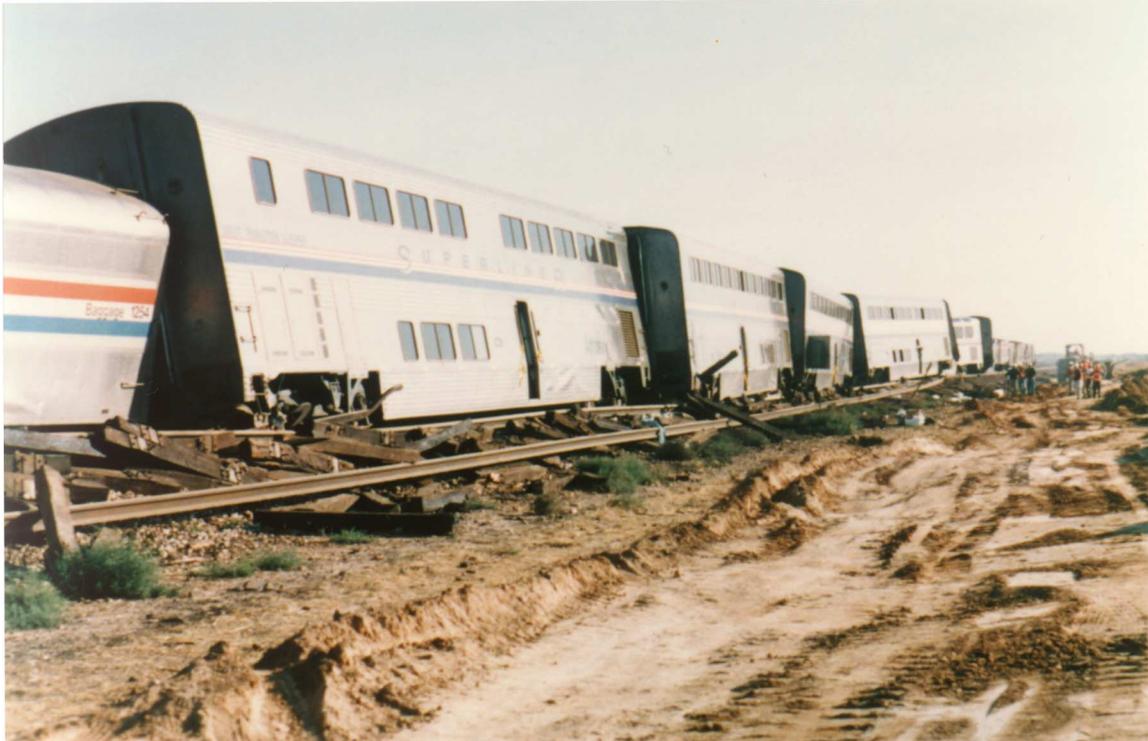
Damage to the locomotive units and cars affected the end vestibule and diaphragm, coupler and coupler pocket, and undercar-mounted equipment. A rail penetrated the 4<sup>th</sup> locomotive unit, ATK 52, from its front, exited through the rear, and extended 19 feet into the first baggage car, ATK 1425. The rail penetrated below the floor level of ATK 52 through the top of the fuel tank; no significant amount of diesel fuel was

Figure 5. Damage to the north side of Amtrak train 4

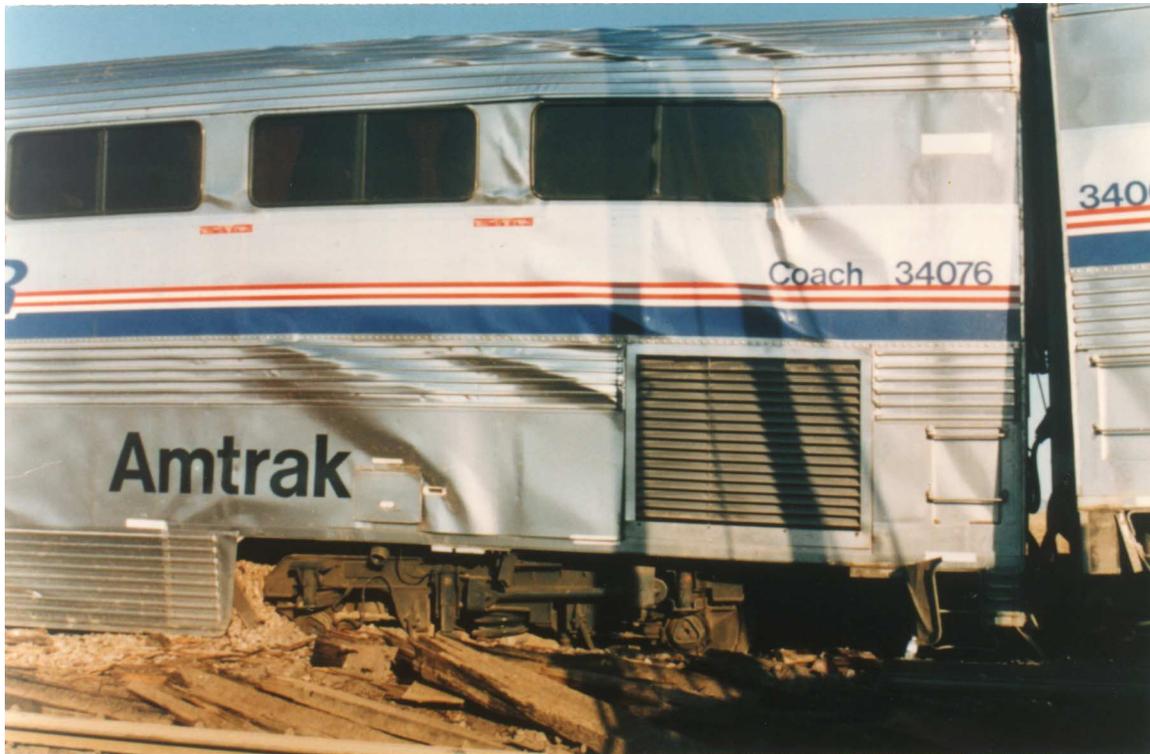
lost. Several passenger cars had structural body damage to their exteriors, consisting of bent or buckled ends. All passenger cars sustained damage to the underside mid-section areas, which rendered the service lighting, emergency lighting, and public address system inoperable. Amtrak considered car ATK 31501, the 6<sup>th</sup> car in the train, a possible total loss. The supporting trucks on five of the six MHC cars had to be rebuilt. (Figures 5 and 6 show, respectively, overall damage to the north side of the train and typical damage to a single coach.)

Figure 6. Damage typical to Amtrak train 4 coaches

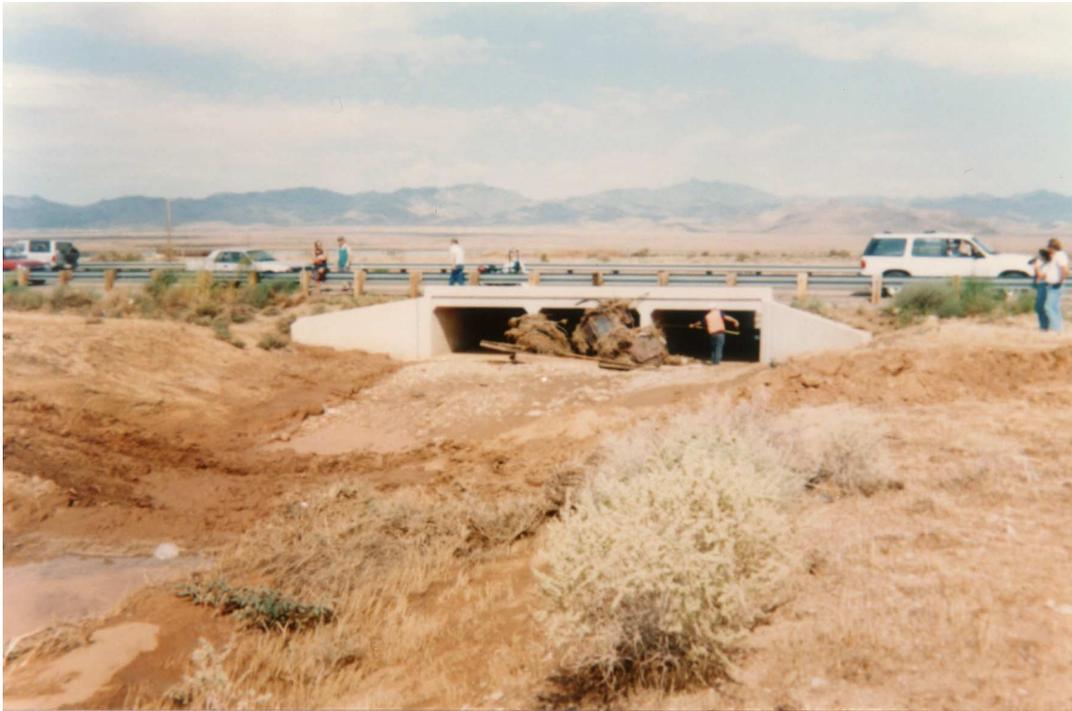
The excavation to place the box culvert probably left a short, steep reach of streambed just upstream of the culvert. This could have initiated the headcut that the aerial photographs show moving upstream from 1954 to 1997 and that eventually contributed to the failure of the crosswall downstream of bridge 504.1.

The box culvert also provided a positive benefit to the channel. The concrete floor of box culvert 4217 is now an elevation control point that will limit the ultimate depth of the long-term channel incision and degradation at

Figure 8. Highway box culvert downstream from bridge 504.1

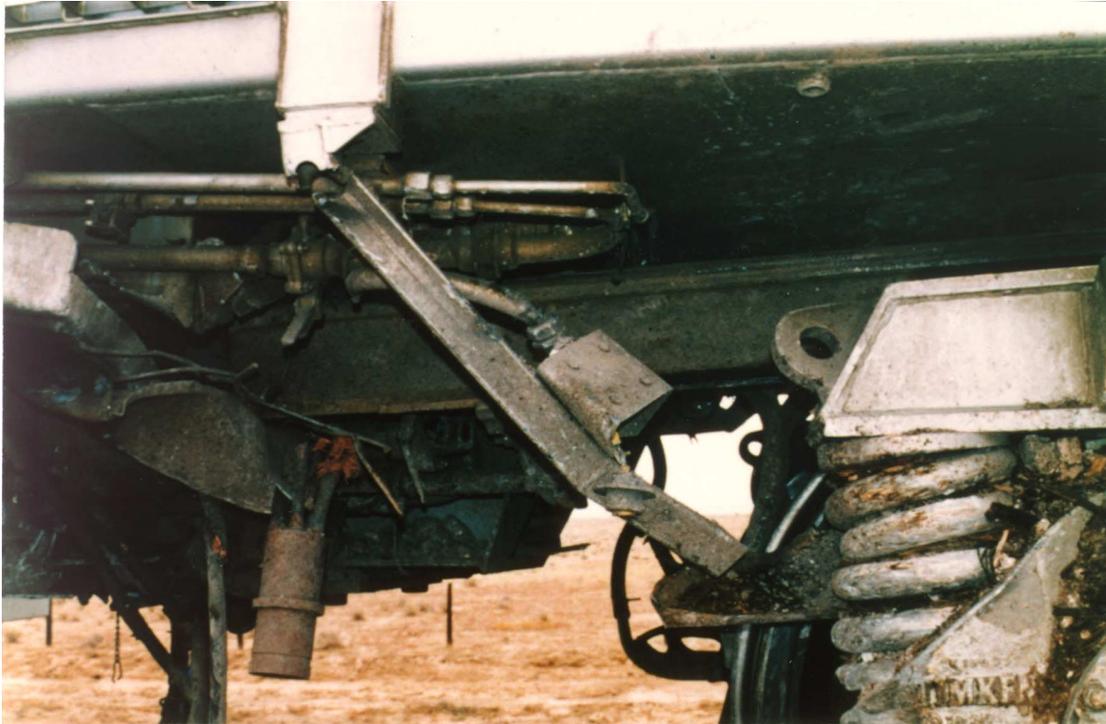
Figure 10. Visible rail segment

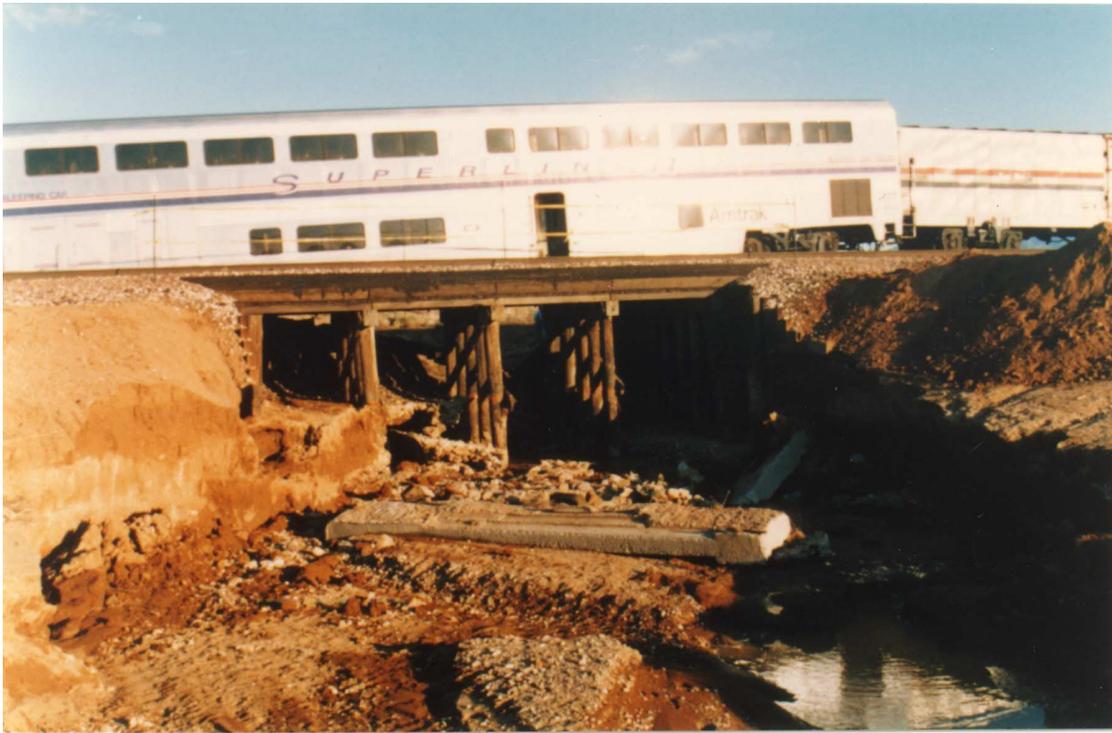
- A combination of long-term degradation and local scour downstream of the crosswall caused the crosswall to fail. Its failure allowed the long-term degradation of the streambed to undermine the grouted riprap, which was protecting the shallow mudsill foundations of the bents. The undermining of the grouted riprap allowed the foundations of bents 3, 4, and 5 to be undermined and to fail.

Figure 13. Crosswall after the accident

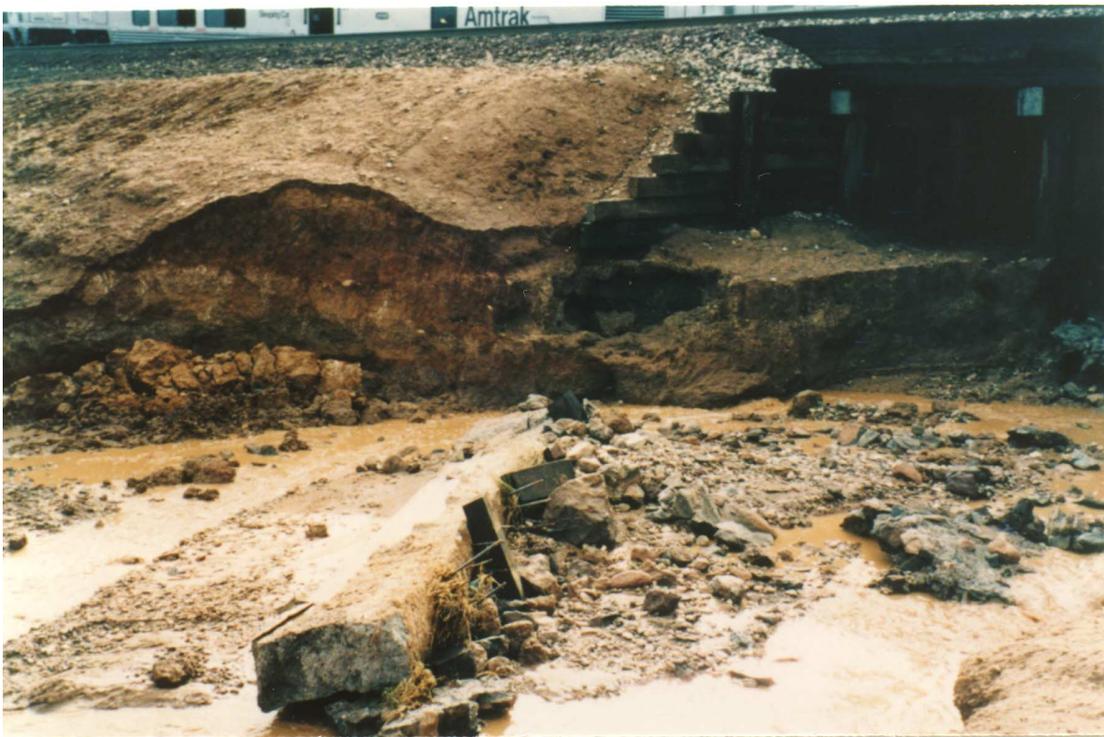
- The August 1997 flood might have caused as much as 3.3 feet of local scour at the crosswall if the peak discharge rate was 450 cfs and as much as 5.6 feet if the peak discharge rate was 875 cfs. Either of these scour depths could have caused failure of the crosswall. The local scour downstream of the crosswall might not have attained its full depth because of the underlying caliche. The caliche at the location of the crosswall was highly resistant to erosion but was still erodible.

Figure 14. Closer view of failed crosswall

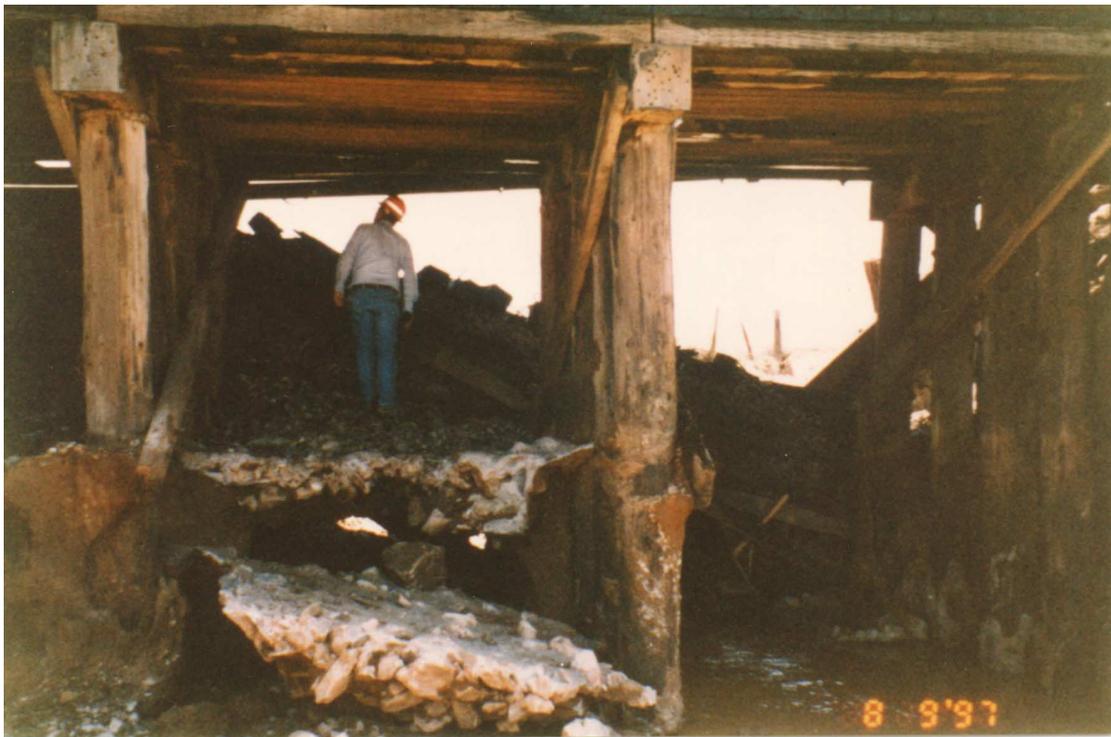
The National Transportation Safety Board determines that the probable cause of this accident was displacement of the track due to the erosion and scouring of the inadequately protected shallow foundations supporting bridge 504.1S during a severe flash flood because the Burlington Northern Santa Fe management had not provided adequate protection, either by inspection or altering train speeds to fit conditions. Contributing to the accident was the failure of the Burlington Northern Santa Fe management to adequately address the erosion problems at bridge 504.1S.

Figure 15. Scour and erosion at bridge 504.1

Consequently, the Safety Board believes that the BNSF should identify and perform a risk assessment of all system bridges that have shallow foundations of similar construction to the bridge that failed in the Kingman, Arizona, accident and replace those bridges determined to be susceptible to undermining and loss of the supporting foundation structure. In conjunction with the risk assessment, the BNSF should perform a hydrology study on shallow foundation structures with questionable drainage areas to determine their current drainage areas. The Safety Board also believes that the FRA should require that all railroads identify and perform a one-time risk assessment of the bridges on their systems that have shallow foundations of similar construction to the bridge 504.1 that failed in the Kingman, Arizona, accident and require replacement of those bridges determined to be susceptible to undermining and loss of the supporting foundation structure. In addition, the Safety Board is concerned that similar situations may exist on other railroad systems in the country that are subject to flash flooding. Therefore, the Safety Board believes that the Association of American Railroads and the American Short Line and Regional Railroad Association should provide information to make their memberships aware of the facts and circumstances of this accident.

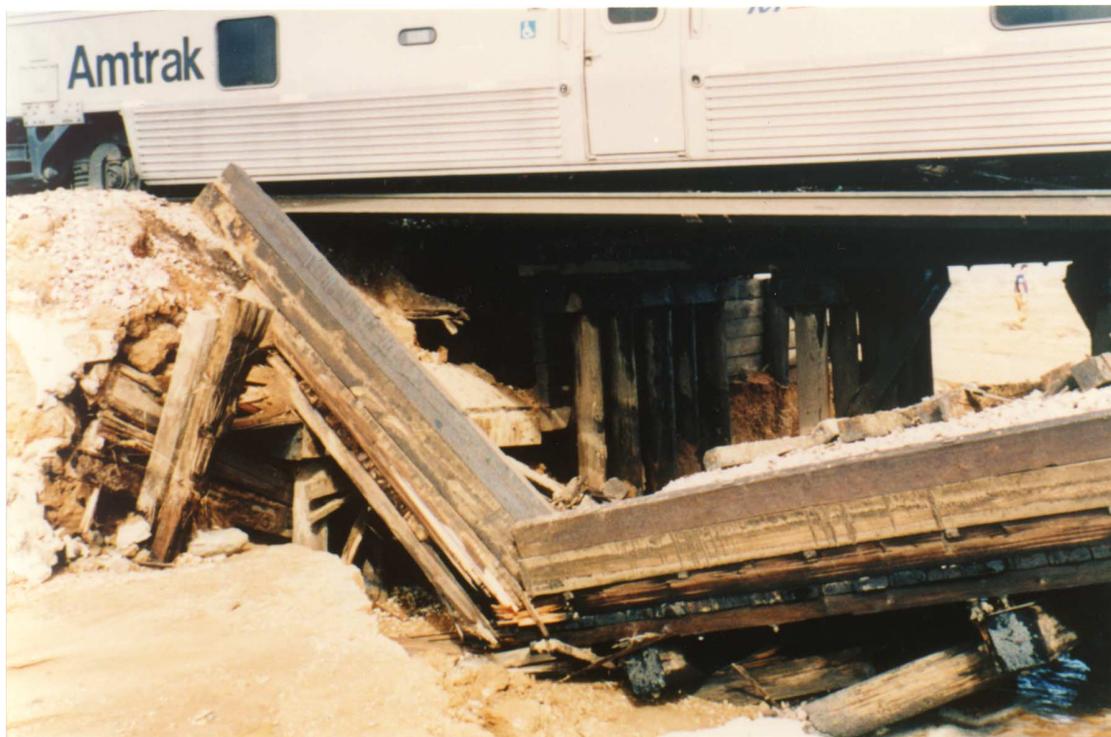
Figure 16. Another view of scour and erosion at bridge 504.1
